Repairing a 7300

Chris G3WIE March 2020

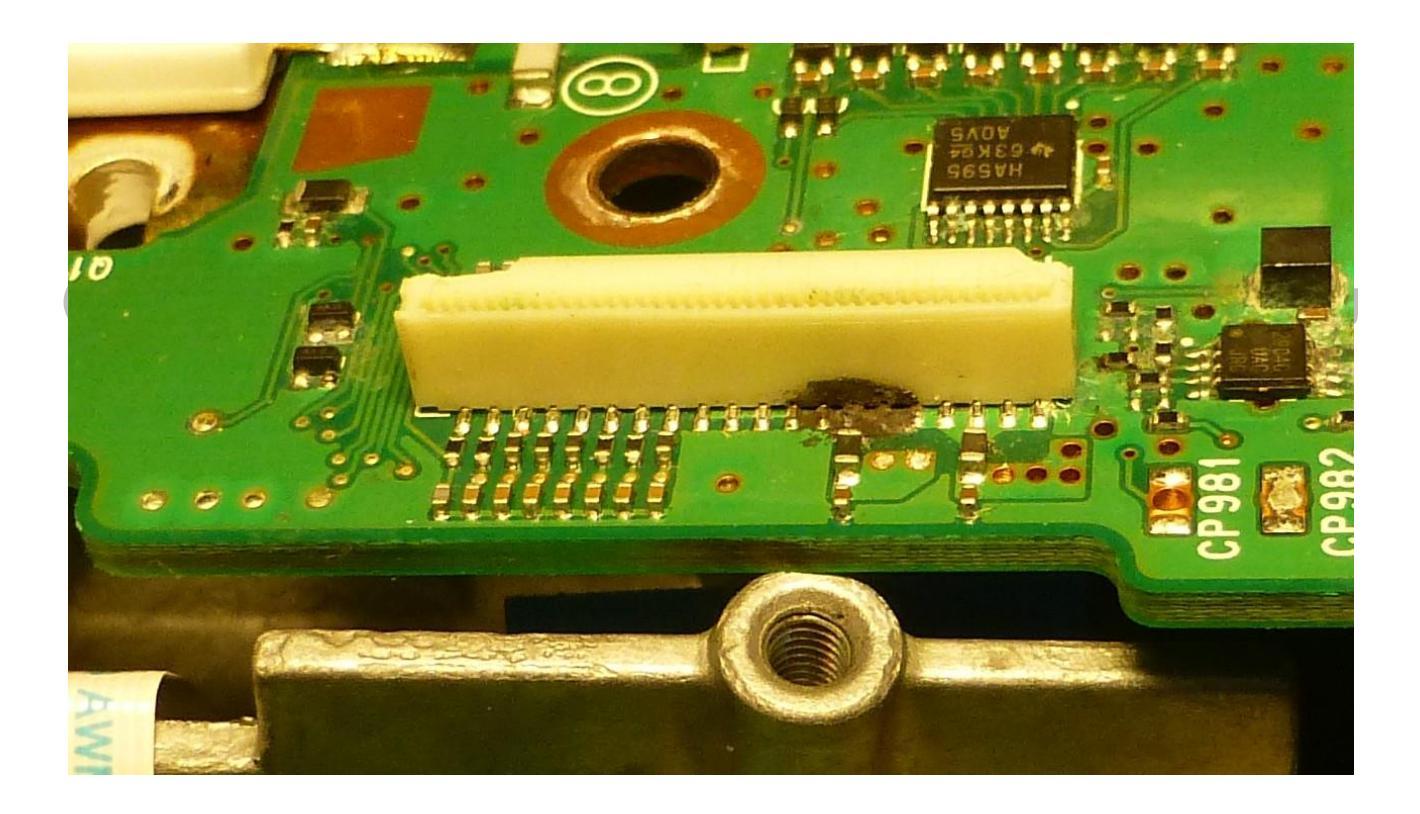
Martin and the distributor had reported some blackening near a connector on the PA. In the top view photo above, it's the connector with the red arrow. This connector carries signals and the permanent power to the DSP/control PCB. If I was designing the radio, I wouldn't send power down one of those cables; far too fragile. Checking against the circuits confirmed that the blackening was around 13v8 power pins.

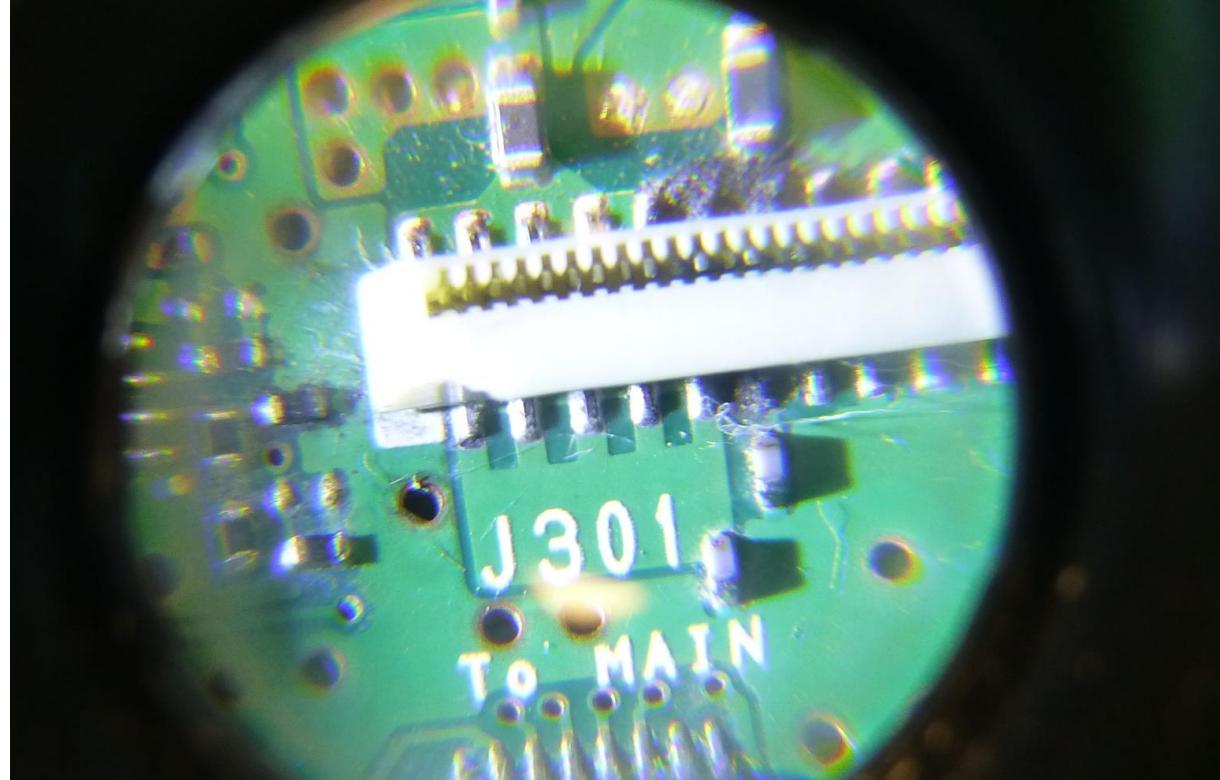
Not particularly surprising, though you may think rainwater is quite pure and hence an insulator. Not this rain it seems. The cable that plugs into that connector is a flexible PCB with 40 tracks on 0.5mm pitch. It has a stiffening piece at the very end and it's pushed into the connector which has wiping contacts to match the tracks

What's going on inside the connector? Here's a photo taken through an eyeglass

(c) G3WIE Source - http://www.ontheradio.org You can see the contacts adjacent to the black on the PCB look different to their neighbours. Luckily they still make contact. Getting that connector off the board would have been very difficult (though possible)

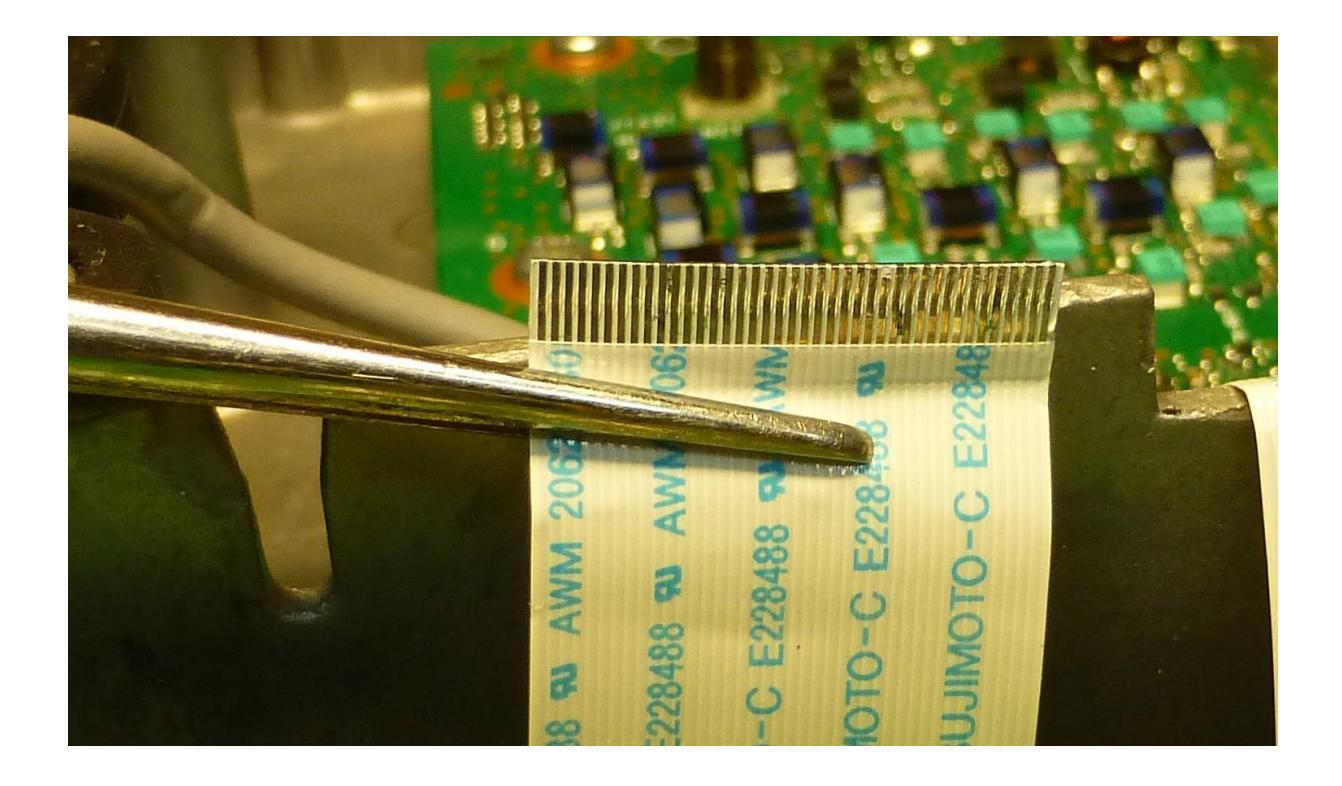
What about the cable? Oh dear it's suffered rather

there's black between some of the tracks, and some tracks look crooked. These tracks lift off the cable substrate very easily at the best of times, and it's going to be worse as it's all been heated up. I cleaned it up as best I could - a very sharp scalpel followed by alcohol. It's pretty difficult to see

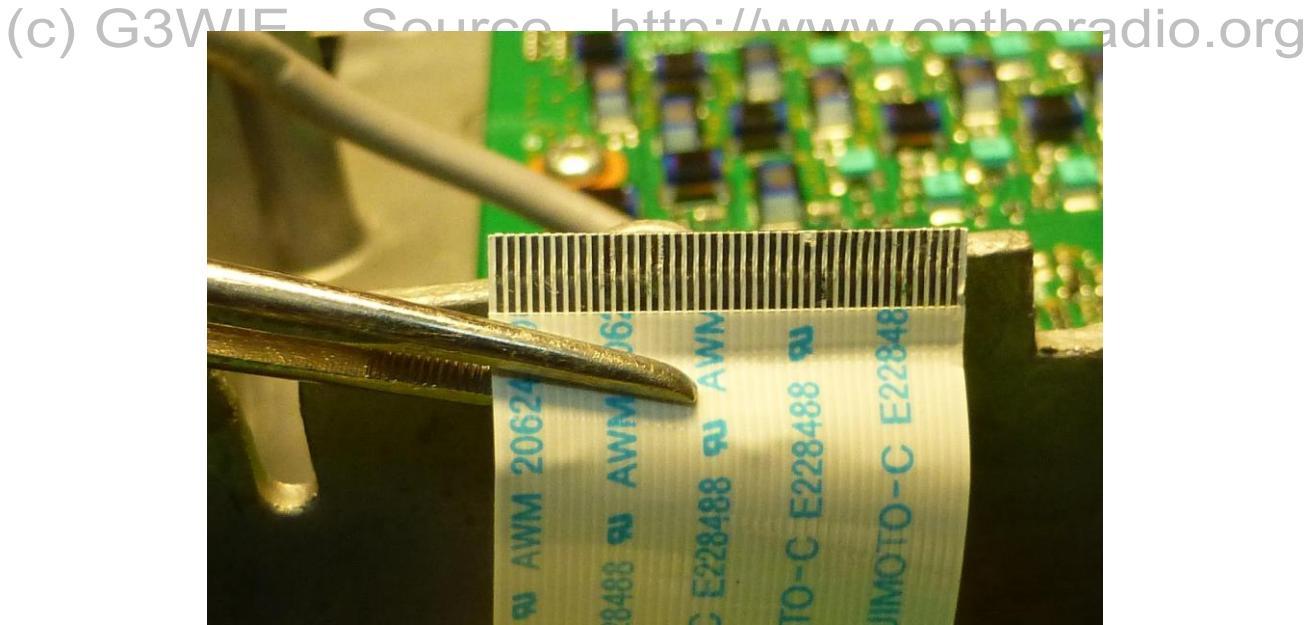
what's in a quarter-millimetre gap between quarter-millimetre tracks

(I did some more cleaning after that photo). Next I got the black off the PCB with some enthusiastic scrubbing with a fibreglass brush and more alcohol. Next, check for continuity between the tiny contacts *inside* the connector and the power input. I use some very fine probes with needle ends (and holes in my fingers to prove they're sharp). No connection. What about from the connector's pins soldered to the PCB? No connection. Sounds like a PCB track is broken somewhere. The track

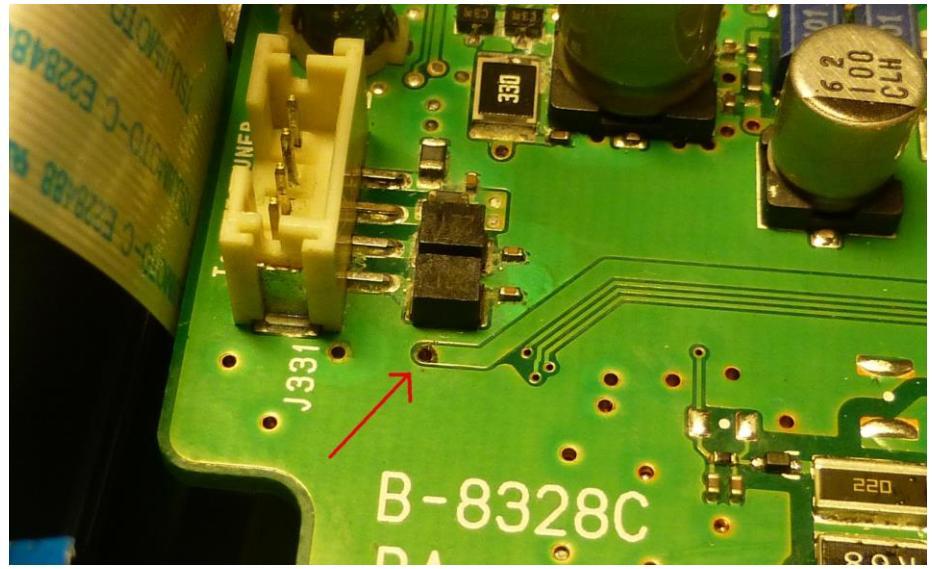
from that connector runs towards the back of the PCB on the underneath, then pops up to the top and continues across towards the power input. The probe's pins are sharp enough to get through the insulating green "solder resist" that PCBs are coated with, and I found there was no connection between that top track and the connector. A good look with an eyeglass showed that the via (the name for a hole in a PCB that's copper plated to connect tracks on top and bottom of the board) had

burnt away. Here it is, suitably magnified (at the end of the red arrow):

The board had to come out of the radio to fix this. Then I scraped away the solder resist on the track on top and bottom of the PCB, poked a piece of tinned copper wire through the via and soldered it to the tracks. Reassemble everything, carefully plug in that fragile flexible PCB. Check and apply power. No smoke, no fire. Press on/off button and hooray the radio powers up! There's a lot of random clicking of relays going on; sounds like the 7300's brain is scrambled. A factory reset shuts them up (and loses all Martin's settings!). Checks with a signal generator showed that the receiver part is ok. This is a good sign as it shows that the damage is most probably limited to the PA PCB.

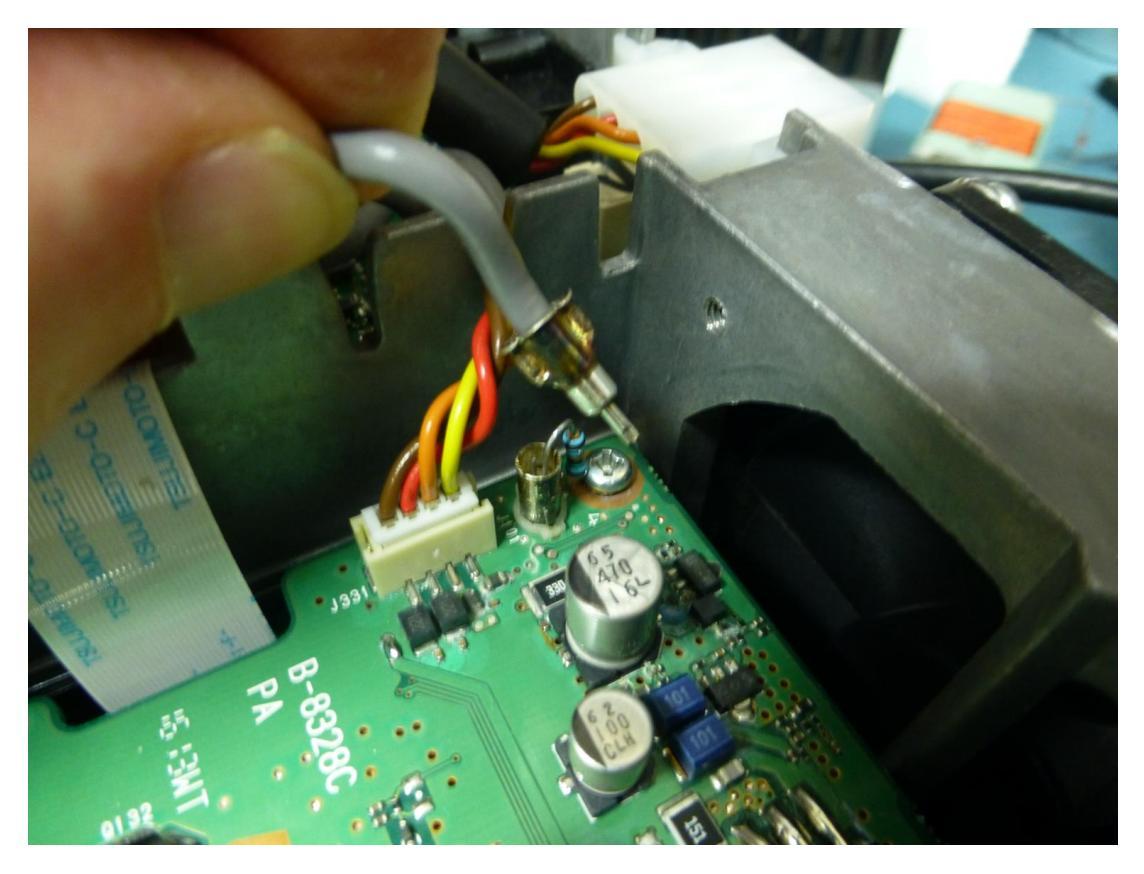
Let's see if the transmit signal is getting to the PA. Unplug the coax connector at the input of the PA and replace with a 51Ω resistor poked into the socket and grounded via a handy fixing screw. Based on past experience, the PA would have a good try at oscillating if its input is left open circuit.

Checking what comes out of the plug with a 350MHz bandwidth oscilloscope shows the RF is being generated on all bands which is a relief. Again this implies the fault is localised to the PA.

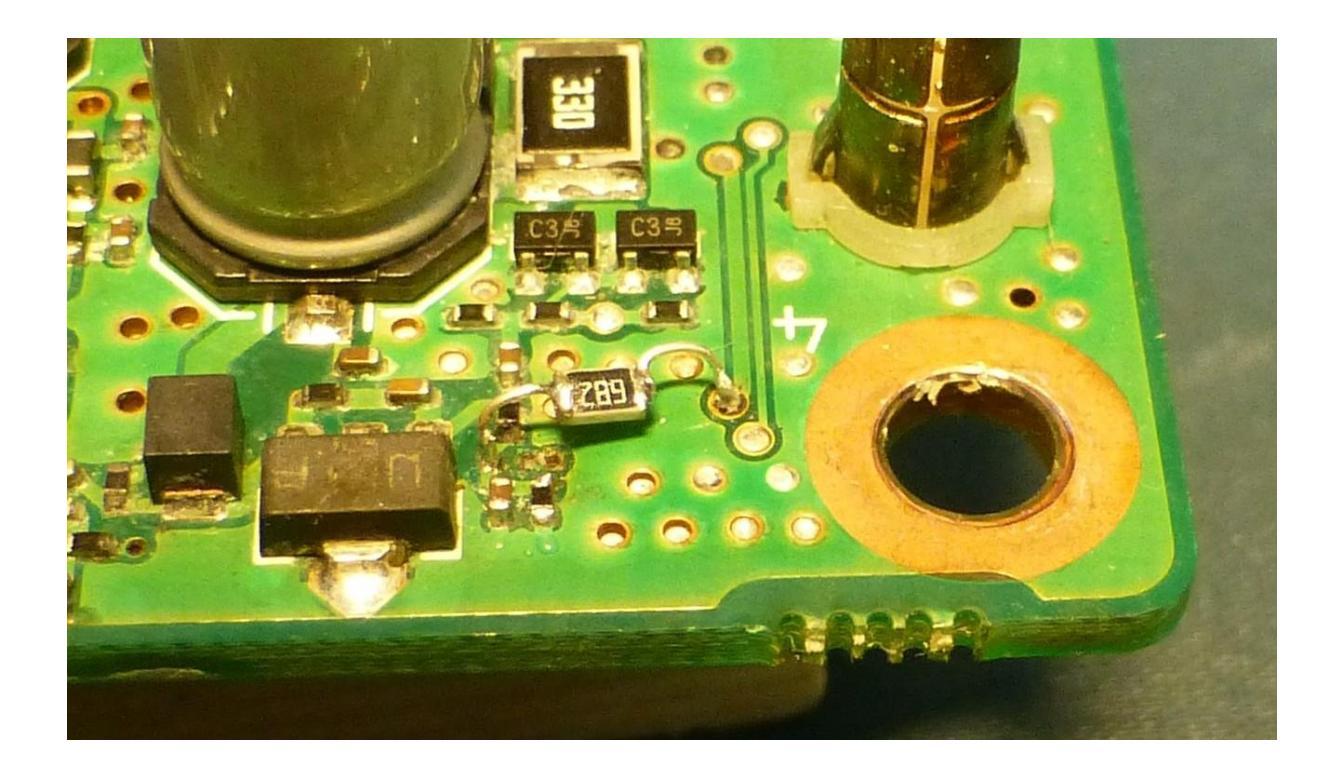
The PA board comes out again. A good look all over with magnifying equipment finds a sad-looking resistor at the back of the PCB in the low-level driver for the PA. I remove it and one of the tracks comes away. It leads to a tiny via which also looks damaged; it's another connection to the (permanent) 13v8 supply. I don't have any wire fine enough to go through the via to repair it as before. In any case, the tracks here are so fine that I wouldn't be able to scrape the solder-resist off and solder to them as they'd just lift off the PCB. A look at the circuit and PCB layout finds a more robust place and I fitted a replacement $6.8k\Omega$ resistor on short pieces of wire.

The original resistors are the little black rectangles in that general area with a metal contact at each end. They are 0402 size which means 0.04" long and 0.02" wide - or 1mm long and 0.5mm wide. My huge replacement is 0805 (2mm x 1-and-a-bit) which is much easier to manage!

Time to have a good look around. A lot of continuity checking against the circuit diagram and PCB layout drawing seems to show everything else in that area is ok. But there is another suspect via in the photo above - can you see it? Again it's on a 13v8 supply - there's a theme here!

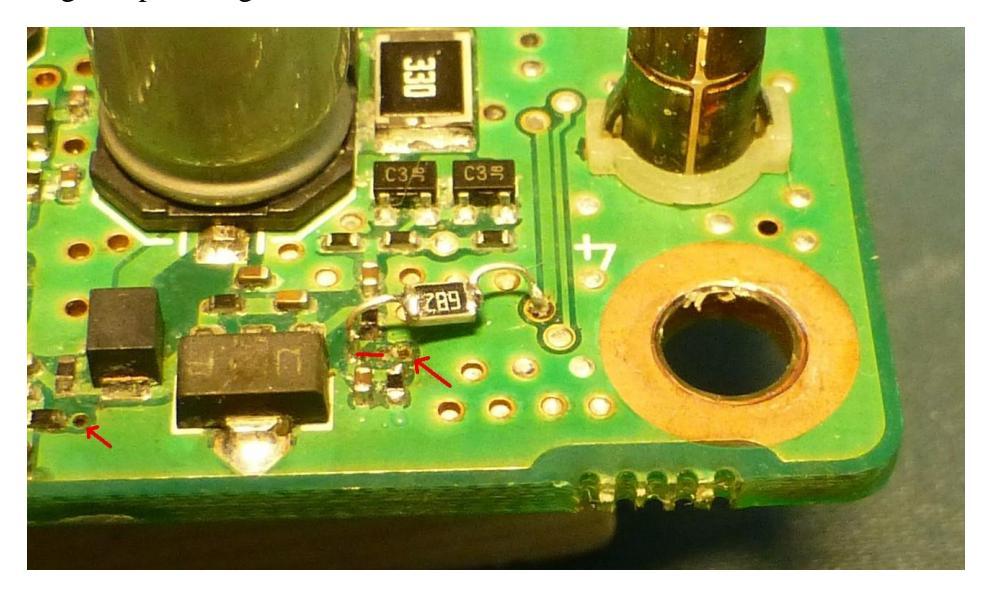
The short red line in the next photo highlights where the dead resistor was, with its accompanying of burnt out via. The other arrow to the left is the where the suspect via is. This via does conduct ok even after poking and prodding it so I left well alone.

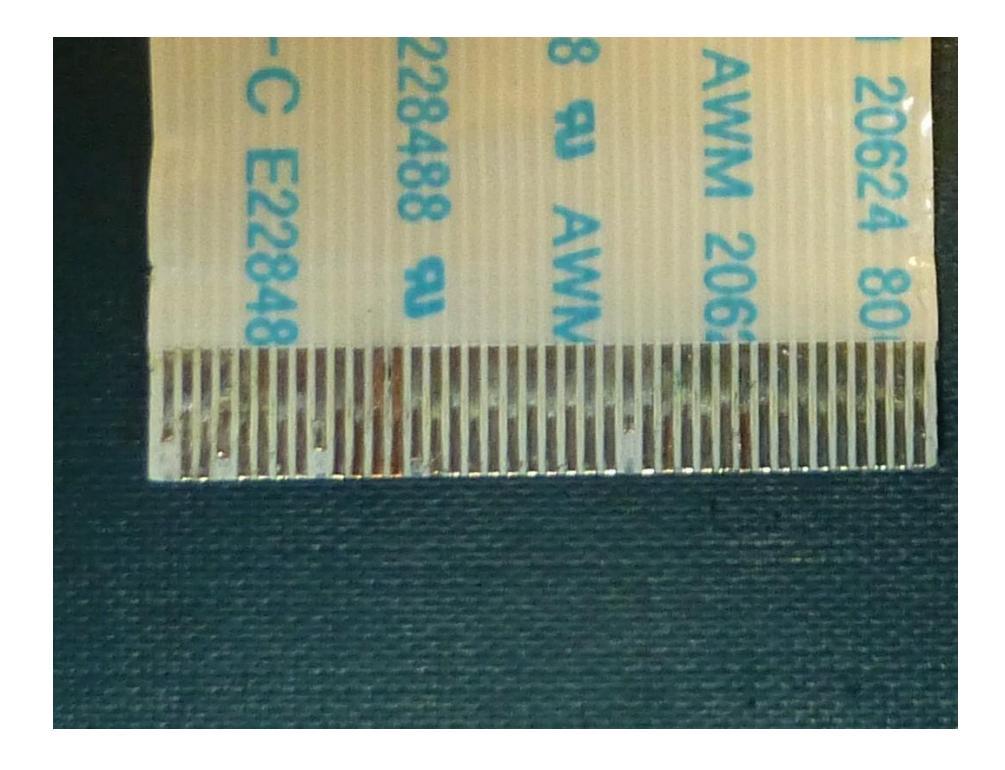
Time to replace the PCB and test the radio again. After another remove/insert in the connector, that flexible cable is looking pretty unhappy now.

Some of the other tracks had lifted when I plugged the cable back in. I cut them back rather than leaving them able to wander about and create more short circuits. Will it connect? Answer - NO. The radio behaves very oddly, changing band does not result in any clicking from the low-pass filter relays in the front of the PA PCB. A cautious try at transmitting with no RF drive shows the PA idling current has gone up a lot. I suspect the PA output isn't connected to anything (no relays closed) and it's oscillating. The cable is beyond repair.

A look at the circuits again shows that all those relays are controlled by the microcomputer via a serial data stream in the cable. I don't fancy trying to wire around the cable to fix a non-connecting track. The tracks might be shorting anyway. Time for a new cable. It has a special Icom part number, but no specification so I measured it carefully. As it happened I was ordering from Digikey in the USA some specialist capacitors for my microwave building. I looked around their website and they sell these cables in a variety of lengths. I found one a bit longer and added two to my order. 3 days later the order turns up, which is good service from afar.
