Repairing a 7300

Chris G3WIE March 2020

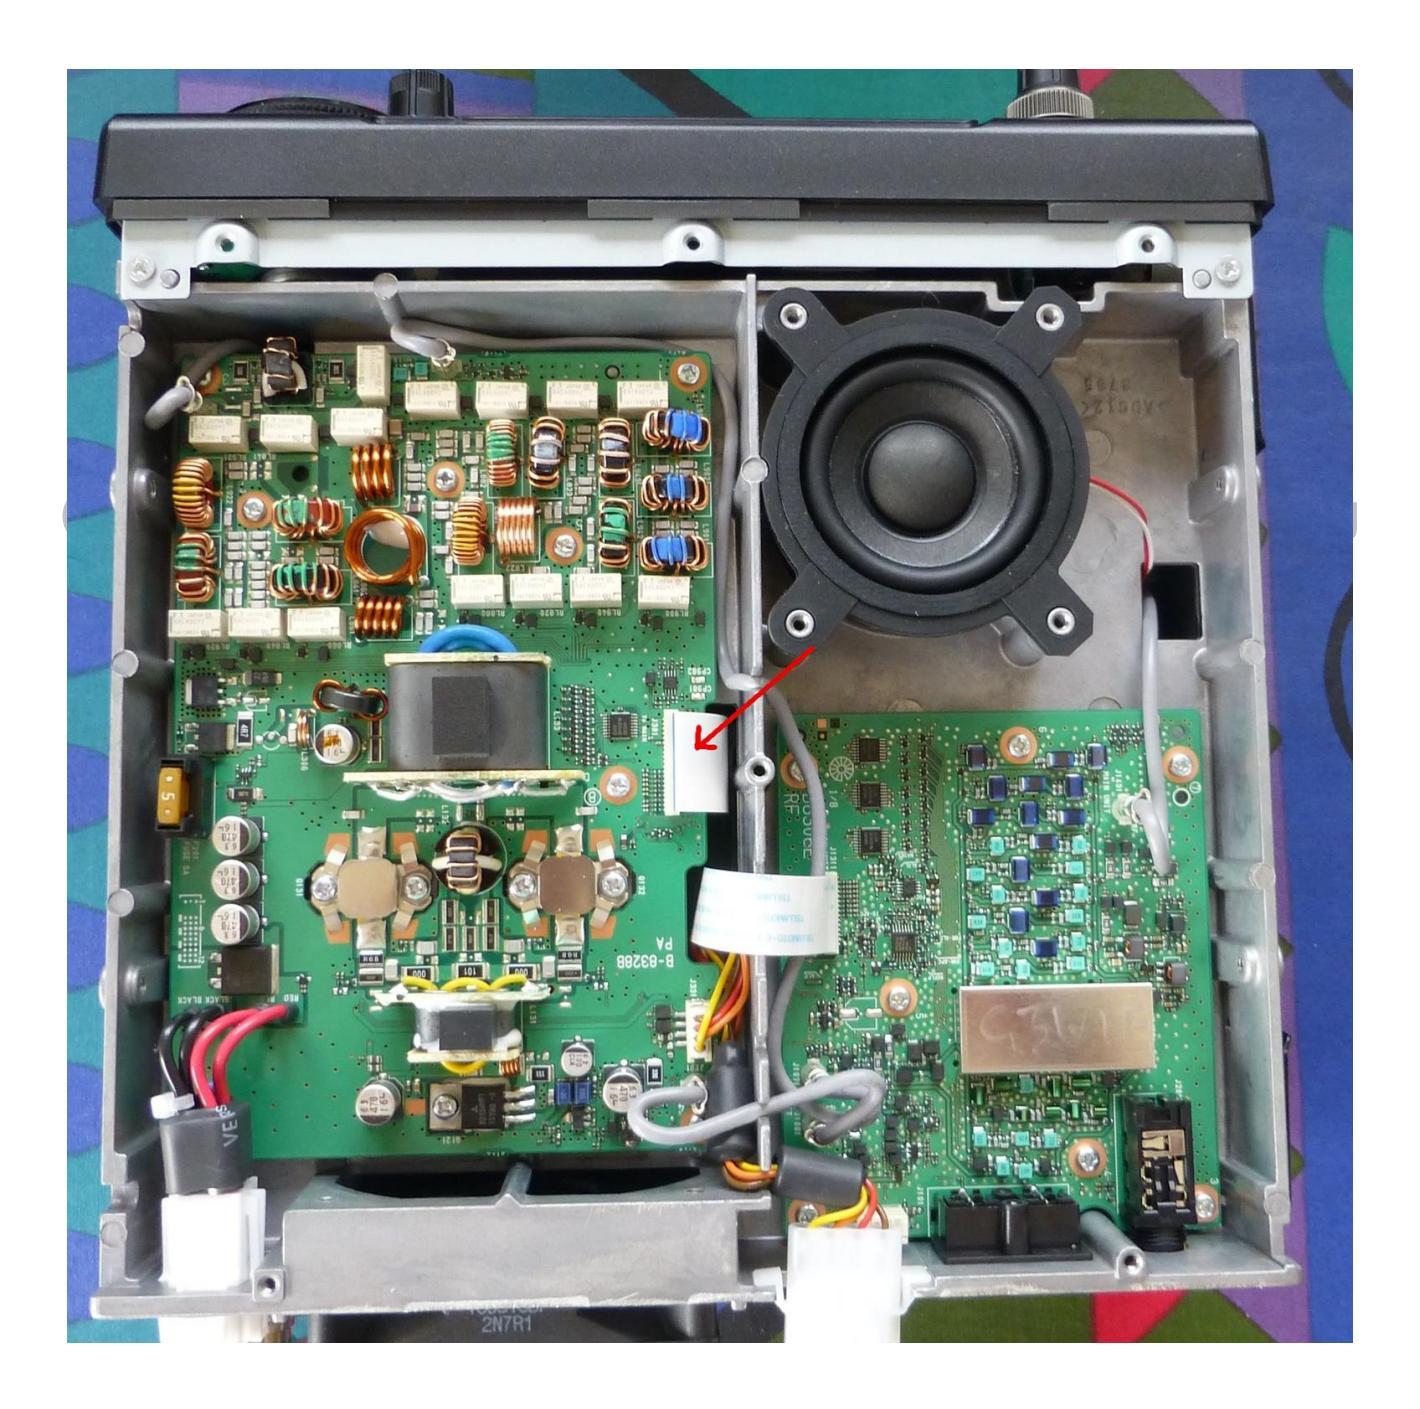
The 7300 has a large diecast aluminium chassis split into 4 compartments containing the 4 main PCBs. The top two contain the PA PCB on the left, and the main RF PCB on the right

Martin and the distributor had reported some blackening near a connector on the PA. In the top view photo above, it's the connector with the red arrow. This connector carries signals and the permanent power to the DSP/control PCB. If I was designing the radio, I wouldn't send power down one of those cables; far too fragile. Checking against the circuits confirmed that the blackening was around 13v8 power pins.
